Seismic Vulnerability Enhancement of Medieval and Masonry Bell Towers Externally Prestressed with Unbonded Smart Tendons

Adolfo Preciado¹, Silvio T. Sperbeck² and Alejandro Ramírez-Gaytán³

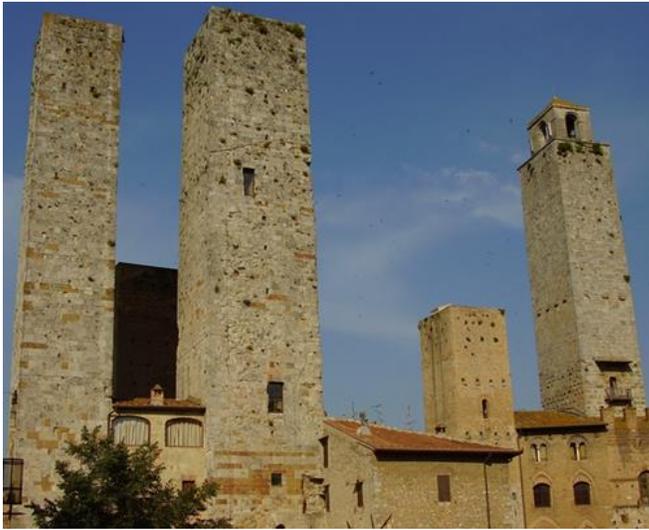
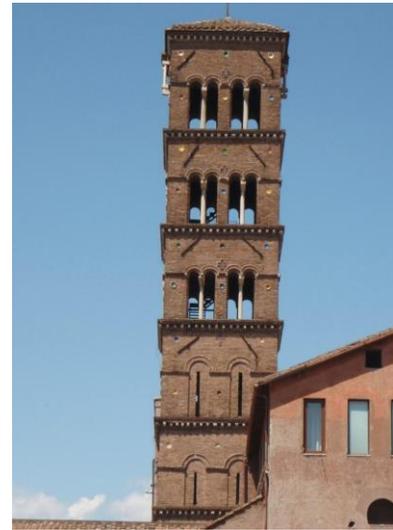
Figure 1: Typical historical masonry towers in Italy; (a) medieval tower and (b) bell tower

General view and FEM models of the medieval and masonry bell towers under study are illustrated in Figure 5. They were selected taking into account common masonry towers with variations in geometry and openings at belfry (see Fig. 1). In following sections, the models are described in detail and initially analyzed by linear analyses and compared against theoretical background. In a subsequent stage, the towers under study are subjected to nonlinear static analyses to assess their seismic behavior and failure modes. Moreover, the towers are retrofitted with a proposed external prestressing device and posttensioning force. The main goal is the achievement of the EQ performance enhancement by providing a better overall behavior of both main groups of towers, bell and medieval, by converting brittle shear failures into ductile ones with higher energy dissipation capability.

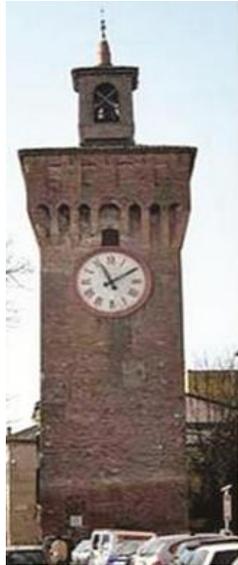
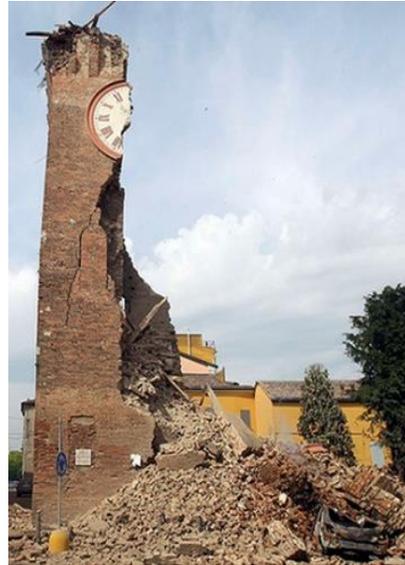
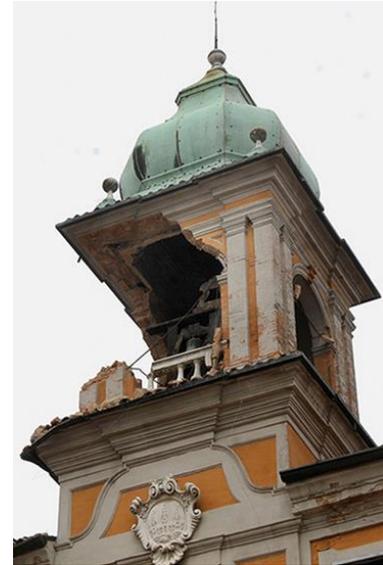
Figure 2: Typical collapses of historical masonry towers under EQ loading; (a) medieval tower (used as clock tower) before and after the EQ and (b) bell tower with large openings at belfry
