# “Earthquake Protection of Colonial Bell-Towers in Colima, Mexico with Externally Prestressed FRPs”

A methodology for the seismic vulnerability reduction of old masonry towers with external prestressing is presented. It is applied at the Colonial bell-towers of the Cathedral of Colima, Mexico, characterized for being a high seismic area ( $M > 7.5$ ). The 3D FE models are calibrated with experimental data and assessed through nonlinear static approaches including the seismic demand and an accurate validated masonry model. Based on an extensive parametric study on different configurations of old masonry towers, it is selected an optimal prestressing force and device. The Colonial towers are retrofitted with four prestressing devices of FRPs to convert them into a high energy-dissipative reinforced masonry. The external vertical prestressing is included at key points identified in the seismic vulnerability assessment. This technique is in compliance with the demand for architectural conservation and may be located without drilling and unbounded in order to be fully removable. The seismic performance is enhanced by increasing force, displacement and internal confinement. It is obser

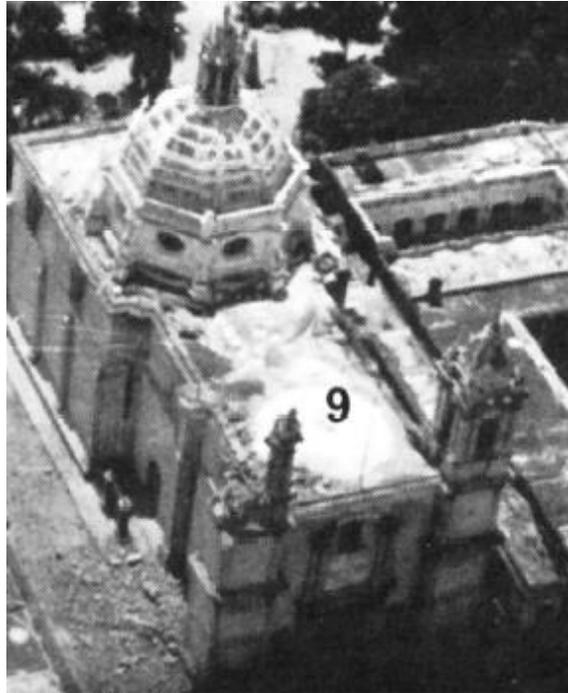
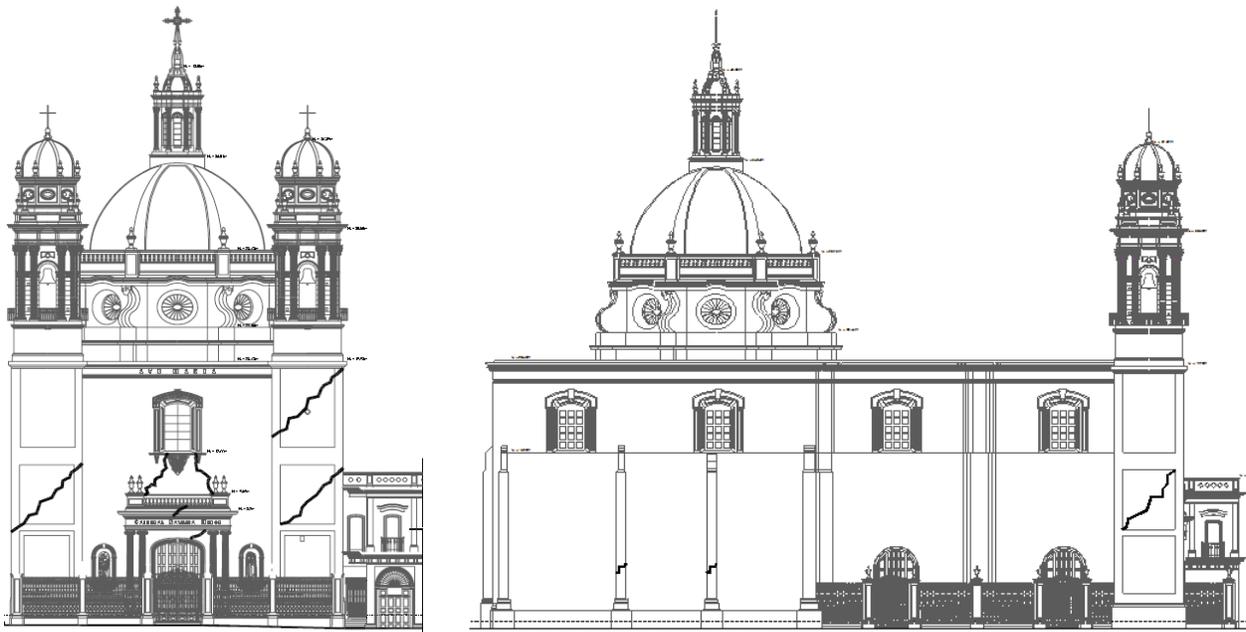
Figure 1: The Cathedral of Colima; (a) observed damage after the 1941 M7.6 earthquake and (b) crack pattern by the 2003 M7.5 earthquake

Both bell-towers of the Cathedral of Colima “*Basílica Menor de Guadalupe*” (Figs. 1 and 3) are selected as case study of this research because of the strong observed damage due to historical EQs, showing once almost a total collapse of the left tower (Fig. 1a). The Cathedral is located in the historical center of Colima City (Fig. 2) and approximately built in 1889 with two bell-towers at the main façade. The building is considered as the most important Colonial monument of Colima by its great historical and cultural value.

The Cathedral of Colima was approximately built in 1889, two years later it was finished the construction of the adjacent chapel. The materials used for its construction were fired clay bricks and carved stone with lime mortar for all the vertical elements such as walls and towers and empty fired clay basins in a matrix of mortar for the vaults. Colima City has been subjected to strong EQs due to its proximity to an important seismic source as described in the seismic hazard characterization. About 10 years after its construction the building was damaged by an EQ, presenting moderate damage at both towers and cupola but strong non-structural damage. In 1941 occurred a M7.6 EQ generated by the subduction of the Cocos plate beneath the North American plate. The strong ground motion was felt in the city with an intensity of X (Table 1). It highly damaged the building, generating important cracking at walls, cupola, vaults and the partial collapse of the left tower. The belfry collapsed almost totally, falling down in a highly transited street (see Fig. 1a), causing for luck just small injuries to some pedestrians. For the tower's reconstruction, materials with similar characteristics were used. Afterwards, in 2003 the city was struck again by another important EQ with the same rupture mechanism of the occurred in 1941. The M7.5 EQ was felt this time with lower intensity (VIII) but caused strong damage to the entire building especially at both bell-towers (see Fig. 1b). The restoration and strengthening works were developed by INAH (2003). The wall thickness was increased by adding thin concrete walls. The vaults were strengthened with a steel mesh covered by mortar and some reinforced concrete beams were included at the level of belfries. Nowadays, the complete Cathedral is in a good conservation state as illustrated in Figure 3a thanks to the 2003 interventions which have shown good performance after recent moderate seismic events.

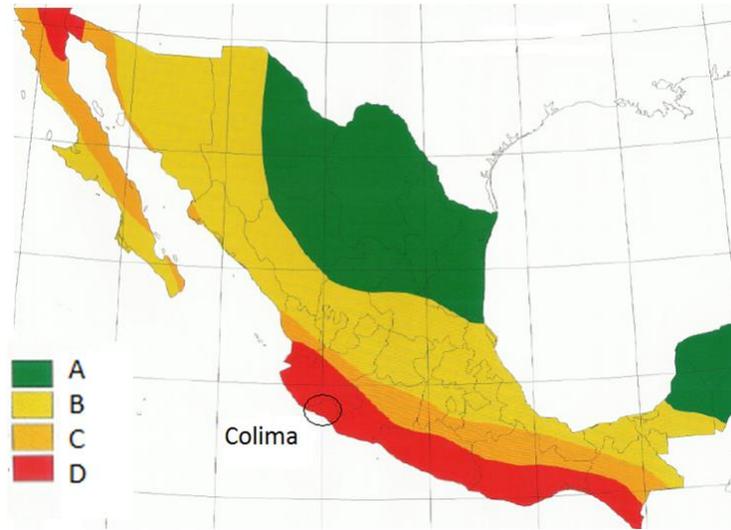
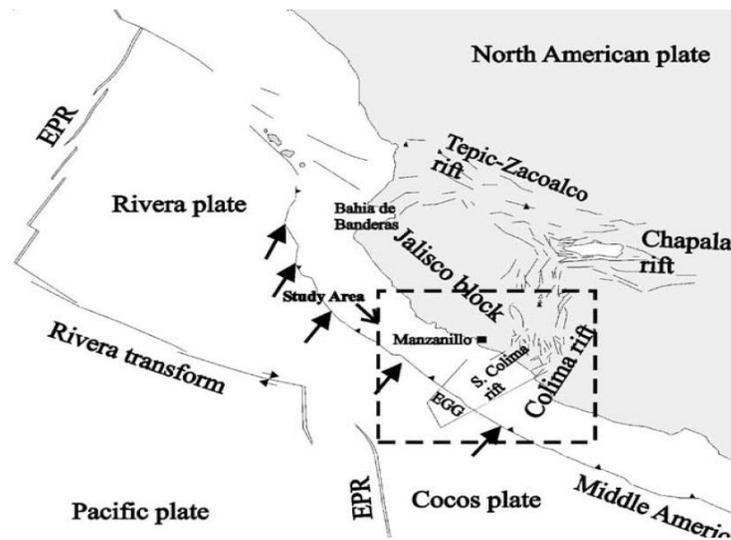
Figure 2: Seismic hazard of Colima; (a) seismic hazard of Mexico, low (A)-very high (D) (MDS-CFE, 2008) and (b) Tectonic map of Occidental Mexico (Bandy et al., 1995)

The state of Colima is located in the Mexican Littoral in the Pacific Ocean with an extension of 5455 km<sup>2</sup> and adjoins with the states of Jalisco in the NW direction and with Michoacan in the SW. At national level, the seismic hazard of Mexico is divided in four main zones ranging from A to D, where A represents low hazard and D very high. In the seismological context Colima is distinguished by its important exposure (seismic zone D), being considered one of the Mexican states under most significant hazard (Fig. 2). Bandy et al. (1995) and Ramirez-Gaytan (2008) describe that the seismic hazard of Colima is determined by three main sources: the active Volcano of Colima that generates constant microseismicity ( $M < 3.5$ ); the Jalisco block located between the Rivera and North American plates and the convergence zone between the Cocos, Rivera and North American plates in front of the coastal area (see Fig. 2b). Mexico is located in the Circum-Pacific Ring, characterized by its high seismicity interplate. The seismic activity is generated by the convergence of the Cocos and North American plates (6 cm/year in average) and the Rivera and North American plates (4.5 cm/year) (Bandy et al., 1995). In the boundaries between plates have occurred major to great EQs causing strong damage to the cities of Manzanillo, Tecoman, Colima, Guadalajara and Mexico (see Table 1). Historically, Colima has been subjected to strong EQs of more than M7.5 and intensities ranging from VII to X. The most recent strong events that have affected the region occurred on October 9<sup>th</sup>, 1995 with M8 and on January 21<sup>st</sup>, 2003 M7.5 (Table 1). According to the Mexican codes MDS-CFE (2008) and NTCDF (2004), as well as the seismic hazard characterization developed at the historical center of Colima City, it is classified as soil type I (stable) and high seismic hazard zone D, with a maximum PGA value (rock site) of 0.50g ( $a_0$ ) with a probability of exceedance of 10% in 50 years and a return period of 475 years. Table 2 presents the summary of the needed parameters to develop the normalized elastic response spectrum.

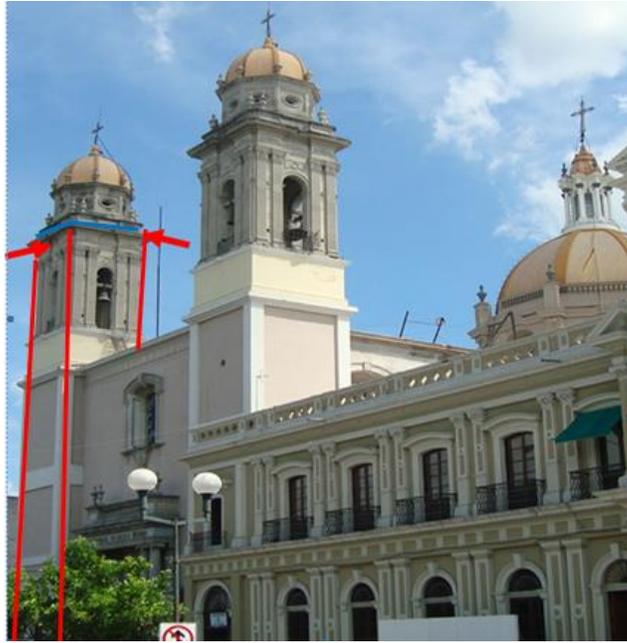
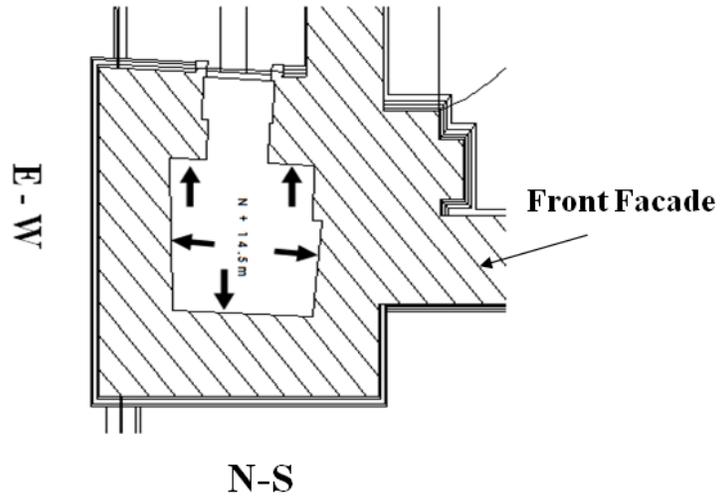
Figure 3: Dynamic experimental campaigns at left belfry; (a) general view of the Cathedral and position of vibration tests and arrangement of prestressing and (b) arrangement of sensors

The EQ assessments of both masonry towers of the Cathedral of Colima are developed through the Pushover technique following a displacement load pattern assuming that the towers behave as cantilever beams of 1 DOF. The horizontal force is applied under monotonically increased top displacement control at the bell-tower at a height of 31 m at the upper level of belfry (Fig. 3a).

The prestressing devices based on tendons are externally applied in the internal four walls of the towers without drilling and fully removable as shown in Figure 3a. The selected FE for the post-tensioned tendon is a uniaxial tension-only 3D spar element (Link10) with linear-elastic behavior. The device is simulated as connected to the supports of the model (foundation) and at the upper level of belfry to a perimetral load-distribution beam (Beam4) to have a uniform distribution of the pre-compression forces. This 3D uniaxial element has linear-elastic behavior with tension, compression, torsion, and bending capabilities. The prestressing force is applied at the tendons by means of strains. This technique is more realistic to account for restoring forces at

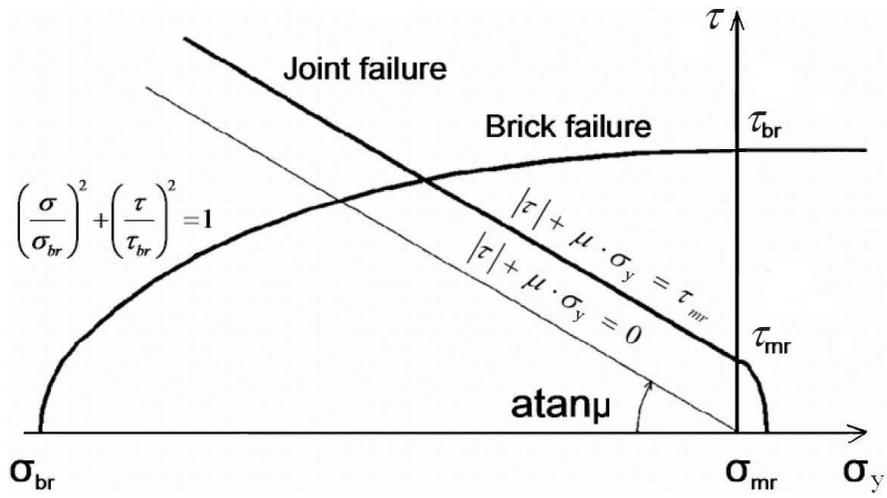
Figure 4: Mortar joint and brick failure domains (Gambarotta and Lagomarsino, 1997)

In the nonlinear analyses through FE models, the homogenized masonry material model developed by Gambarotta and Lagomarsino (1997) is implemented. This material model is capable to simulate the main failure mechanisms and behavior of masonry structures in static and dynamic conditions. This accurate material model has been validated by theoretical background and reported experimental examples in the research work of Preciado (2011). The constitutive model is integrated in the commercial finite element program ANSYS® by subroutines and based on the macro-modeling approach which is considered as appropriate for the seismic assessment

of large historical constructions. Furthermore, the suitability of the material model in masonry structures has been proved through numerical simulations against experimental results e.g. Calderini and Lagomarsino (2006). The continuum damage model is based on a micromechanical approach where masonry is assumed as a composite medium made up of an assembly of units connected by bed mortar joints. The contribution of head joints is not considered. The constitutive equations are obtained by homogenizing the composite medium and on the hypothesis of plane stress condition. The failure limit states for mortar and unit damage are depicted in Figure 4. The homogenised model is characterized by three yield surfaces determined by tensile failure and sliding of mortar joints considering the Coulomb friction law and compressive failure of units. In summary, if tensile stresses act in mortar bed joints  $\sigma_y \geq 0$ , three damage mechanisms may become active: failure of units, sliding and failure of mortar bed joints. By the other hand, if mortar joints are under compressive stresses  $\sigma_y < 0$ , then both damage mechanisms of units and mortar are activated.

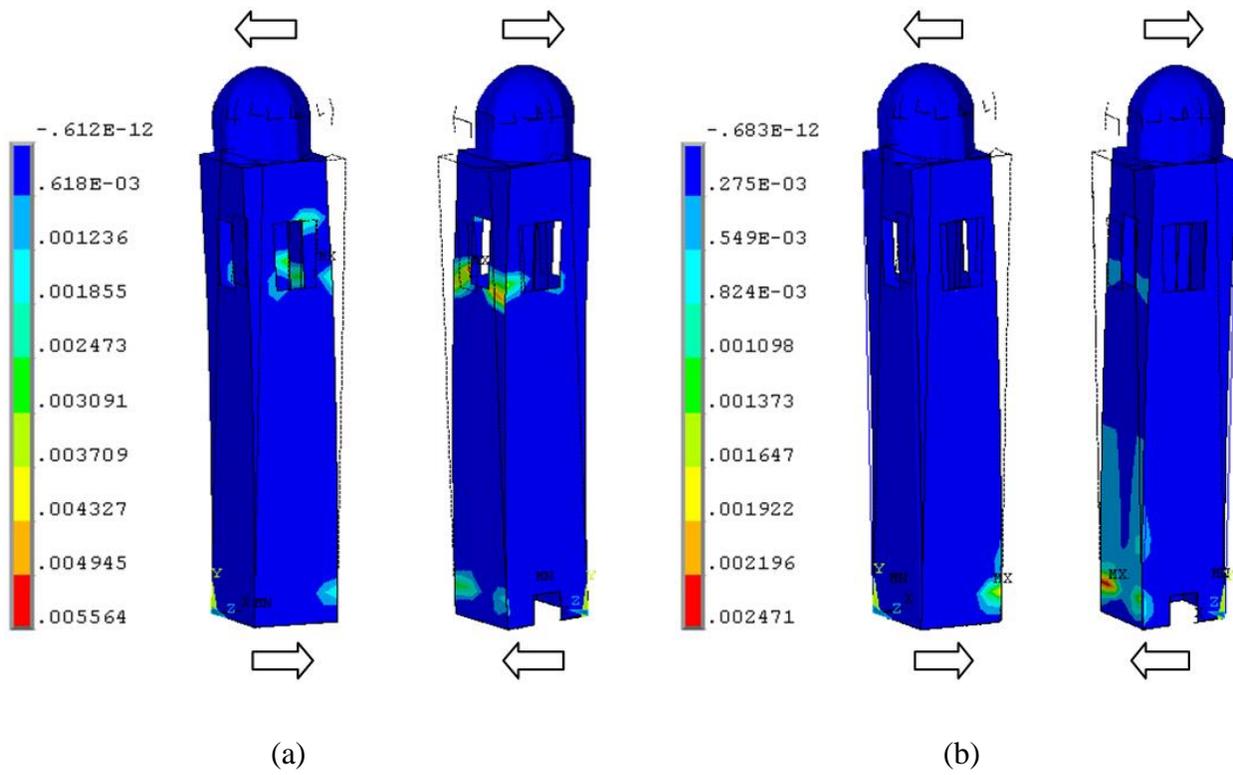
Figure 5: Comparison of principal plastic strains (front and back) at a displacement of 100 mm for a seismic action in  $-X$  (S-N): (a) original (ULS) and (b) retrofitted 0.30Fv

failure mode at ultimate limit state (ULS) of the tower without springs for a seismic action in the  $-X$  direction is presented in Figure 5a. It is worth noting several flexural cracks at the lower part of the body and failure of belfry by a combination of flexural cracks out-of-plane and shear in-plane. The model with springs ( $+X$  direction) is stiffer as expected due to the interaction with the façade, presenting the failure of belfry by shear cracks (Fig. 6a). This brittle behavior is due to the large openings and the short column effect which reduces the flexural height of slender structures. The obtained failure mechanisms through numerical simulations are in complete agreement with the observed after real EQs and are characteristic of bell-towers (flexural cracks at body and shear at belfry). The different seismic performances of both models could be observed at the capacity curves illustrated in Figure 7. It is worth noting that the left tower under seismic action in  $-X$  direction presents at ULS a maximum displacement of 100 mm and a lateral force of 2741 kN. Compared to the brittle constrained  $+X$  model, the  $-X$  model presents its characteristic bending behavior due to the disconnection with the façade, represented by 25% of more displacement capability (see Table 5). The  $+X$  model is more resistant to horizontal loading (12%), but less ductile, which is not relevant for seismic energy dissipation purposes, it is more important to reach more ductility with no brittle failure. For this purpose, the technique of prestressing is quite helpful to reach a seismic upgrading of URM structures by increasing strength, ductility and internal confinement.

For similitude of results only the corresponding to the high prestressing level are presented ( $0.30F_v$ ). It is worth noting at the comparative of failure mechanisms of Figures 5, 6 and 8 that prestressing considerably reduces damage at belfry. The seismic performance is enhanced by increasing force, displacement and confinement as shown at the comparative of capacity curves of Figure 8 and Tables 5 and 6. It is observed an upgrading of 35% of displacement (30.2% of force) at the  $-X$  model and 20% of displacement (21.5% of force) at the constrained  $+X$  model. With these results it is corroborated that external vertical prestressing allows a substantial increment of the ductility of historical masonry towers and may be transformed into a high energy dissipation system by the formed loop at the capacity curve. The assessment and risk reduction summaries are presented in Tables 5 and 6. The seismic coefficient of the  $-X$  model in original state (0.126) is in good agreement with the obtained by Preciado, 2007 (0.120) by means of 3D limit analysis approach, as well as with the observed damages after passed EQs. At ULS no crushing is observed:  $-X$  original state 1.80 MPa, retrofitted 2.38 MPa;  $+X$  original state 1.15 MPa, retrofitted 1.48 MPa. In all cases (original state and prestressed condition) the obtained compressive stresses are lower than the intrinsic strength of 2.5 MPa. In the seismic evaluations of the bell-towers by the CS method of Figure 9, it is worth noting that the retrofitted tower is able to withstand a seismic action in  $-X$  thanks to the energy dissipation enhancement, but not enough in  $+X$  due to the façade constraint. Even by applying a medium prestressing level

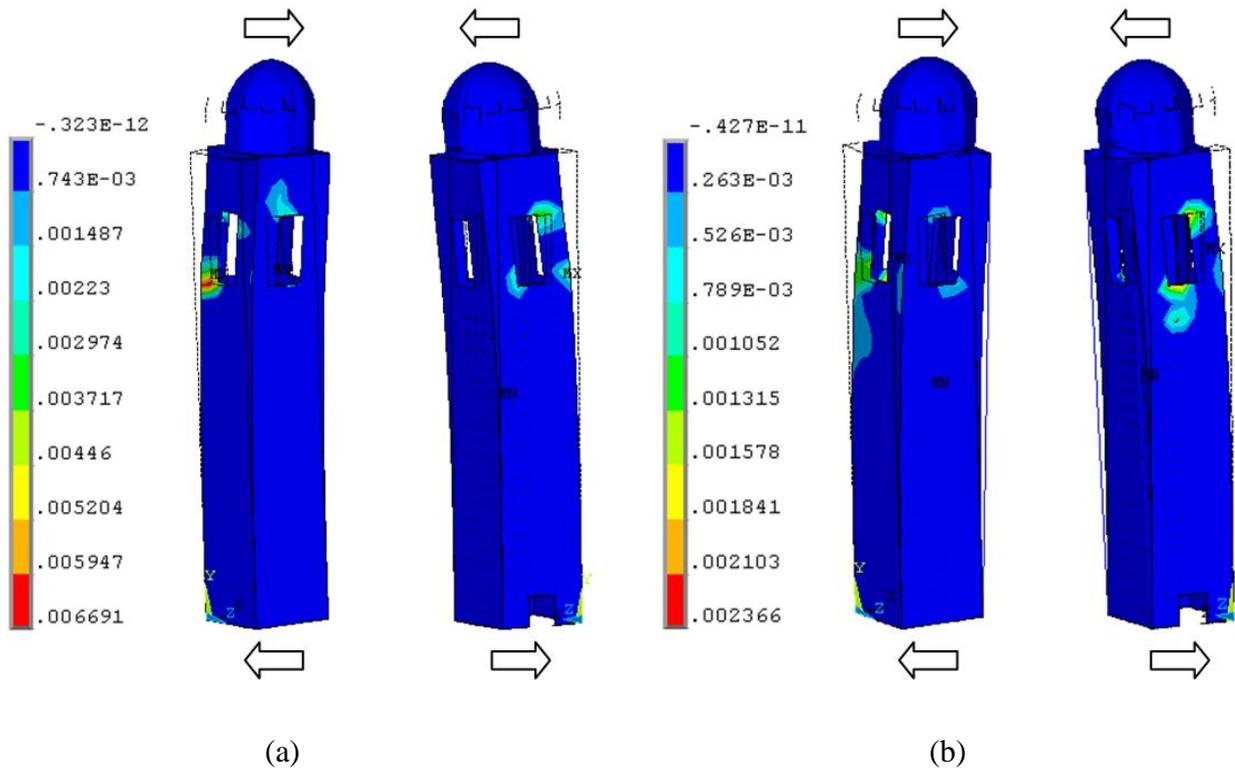
Figure 6: Comparison of principal plastic strains (front and back) at a displacement of 75 mm for a seismic action in +X (N-S): (a) original (ULS) and (b) retrofitted 0.30Fv

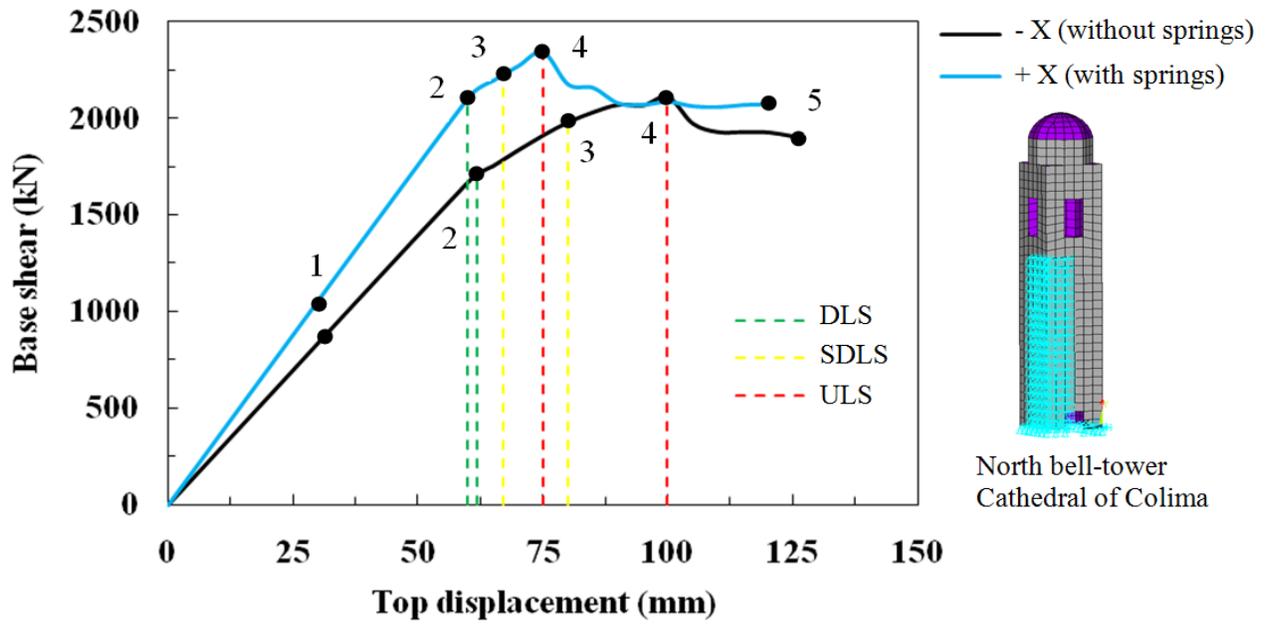
Figure 7: Comparison of capacity curves in original state for a seismic action in  $-X$  and  $+X$  with the damage grades (EMS-98) and limit states (EC-8)

In order to have comparative indicators of performance it is included at the capacity curves the EQ performance limit states established by the European Code (EC-8) (Eurocode 8, 2004); the damage limit state (DLS) at first yielding; significant damage limit state (SDLS) representing significant damage and the ultimate limit state (ULS) near collapse. Moreover, these limit states at the capacity curves are correlated to the damage grades (DG) DG2, DG3 and DG4 proposed by

the European Macroseismic Scale (EMS-98) reported in Grünthal (1998). For having quantitative indicators of performance at the capacity curves, it is included the seismic coefficient (CS) determined by the ratio between the ultimate lateral force and the vertical loading. The seismic coefficient is typically expressed as a fraction or percentage of the gravity ( $g$ ). The main drawback of this indicator is that only the lateral strength of the structure is evaluated, disregarding the displacement and ductility which is extremely important in the EQ assessment of structures for energy dissipation capabilities (see Tables 5 and 6).

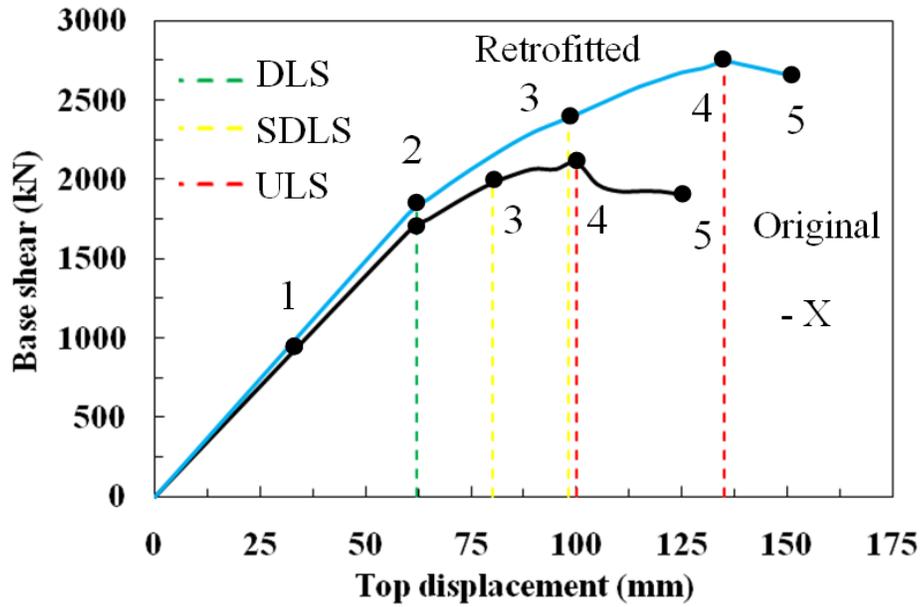
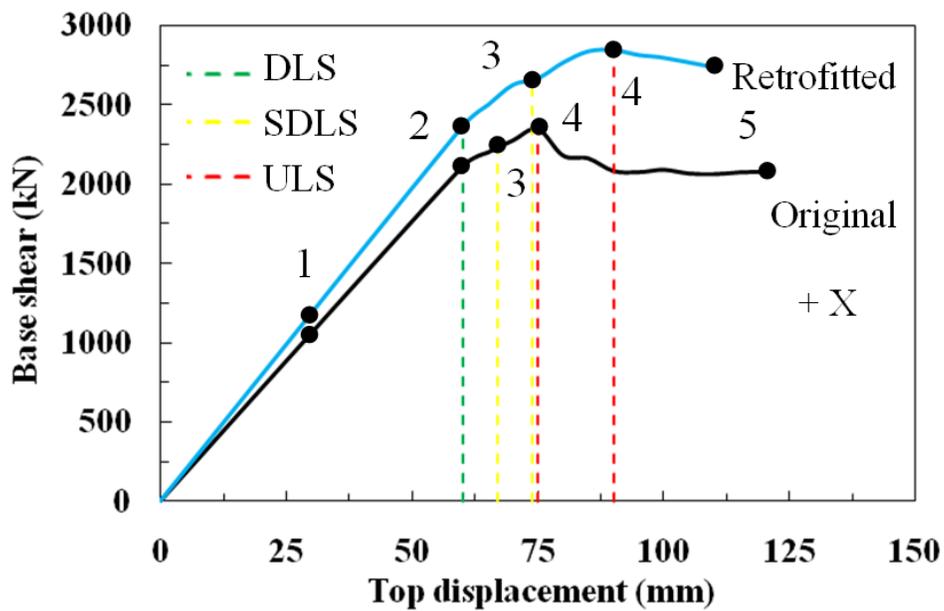
Figure 8: Comparison of capacity curves in original state and retrofitted (0.30Fv) with the damage grades (EMS-98) and limit states (EC-8): (a) -X and (b) +X springs

( $0.15F_v$ ) that allows more ductility enhancement, the maximum obtained displacement of 100 mm is lower than the target one of 105 mm (Table 7). To bring the additional ductility, a combination of the Technora prestressing devices with an internal wrapping of belfry (GFRP sheets) is suggested.

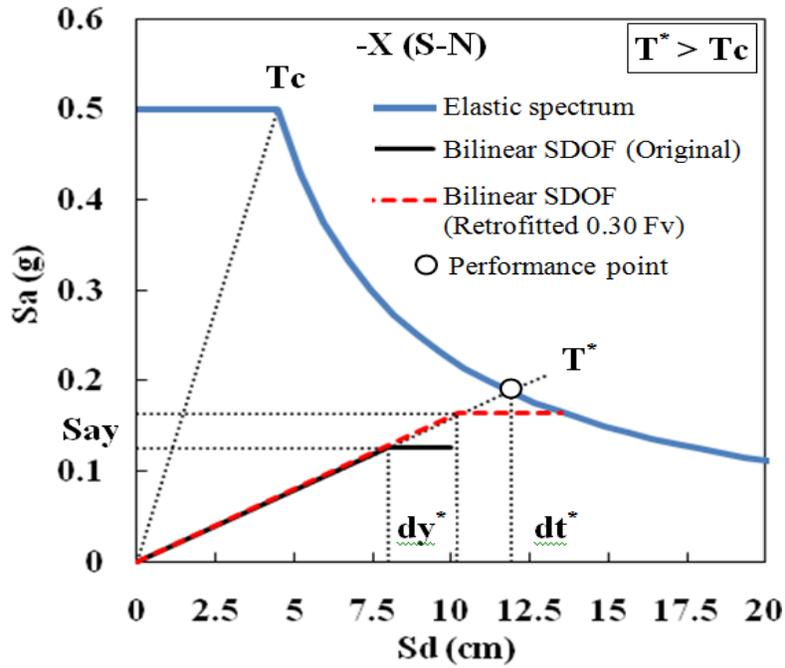
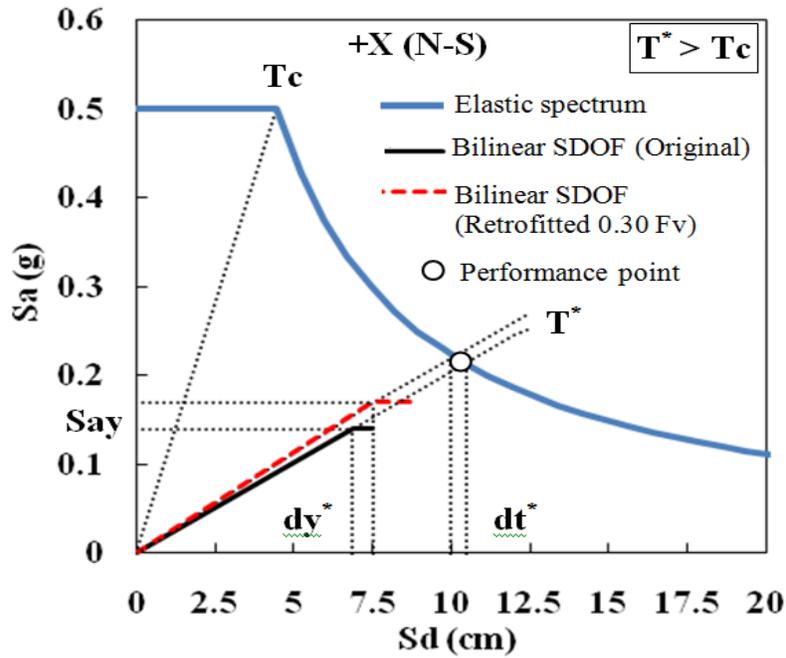
Figure 9: Seismic evaluation of the north bell tower of the Cathedral of Colima by the Capacity

For assessing the seismic performance of the historical masonry bell-towers, the Capacity Spectrum (CS) method proposed by Fajfar (2000) is used. The aim is to graphically identify the performance point by the intersection between the capacity curve transformed into an equivalent SDOF system and the seismic demand represented by the elastic spectrum properly reduced. Figure 9 illustrates the converted capacity curves of the  $-X$  (disconnected) and  $+X$  (constrained) models, as well as the elastic response spectrum based on the seismic hazard characterization of Section 3. Since  $T^* > T_c$ , the target displacement is directly obtained without reducing the elastic response spectrum. Figure 9 illustrates the transformed capacity curves into bilinear curves of the  $-X$  and  $+X$  model for computing the ductility available against the seismic demand. The maximum reached displacement  $d_m^*$  for both models ( $-X$  and  $+X$ ) is not enough to withstand the seismic demand represented by the target displacement  $d_t^*$  (performance point). The maximum performance of the  $-X$  model is of about 19% less than the required performance and even more drastic the  $+X$  model with a poor performance in the order of 40% (Table 7). The  $-X$  model fails more ductile than the  $+X$  model as depicted on Figures 5a and 6a. The  $+X$  model presents flexural cracks at the lower part of the body and failure of belfry by a combination of bending

and shear stresses that allowed it to perform better than the +X model, which fails by shear stresses at belfry.
