Vulnerability assessment of churches at Colima by 3D limit analysis models

A. Orduña, A. Preciado, F. Galván & J.C. Araiza
University of Colima, Colima, Mexico

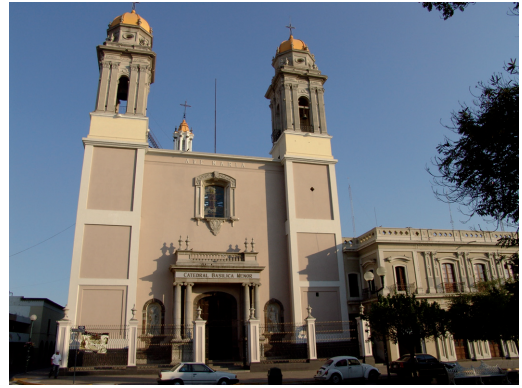
Figure 6. Cathedral "Basilica Menor de Guadalupe" (a) façade; (b) plan view.

The cathedral (Fig. 6) was built in 1889 and is considered the most important historical building in Colima State. This building is larger and more architectonically sophisticated than the chapel "Virgen del Refugio".

The vertical structure of the construction includes a stone masonry foundation, thick masonry walls made of solid clay bricks, and two bell towers made of stone masonry at bottom and clay brick masonry in the upper part. The roof system consists of masonry

vaults, and a clay brick masonry cupola, both supported on arches of the same material. The masonry of the vaults is an interesting case because the pieces are small pots of fired clay. May be the original idea was to achieve a light weight material, compared to solid pieces masonry. The survey after the 2003 earthquake showed extensive cracks in most walls, fairly large pieces of fallen plaster and towers fractured. In the roof system were large and extensive cracks in most vaults and large pieces of fallen plaster.
