1ST INTERQUADRENNIAL ICF CONFERENCE
IN MIDDLE EAST AND AFRICA

Processing, Performance and Failure Analysis of
Engineering Materials
February 14–17, 2011, Luxor, EGYPT

SEISMIC BEHAVIOR AND FAILURE MECHANISMS IDENTIFICATION OF ANCIENT MASONRY TOWERS

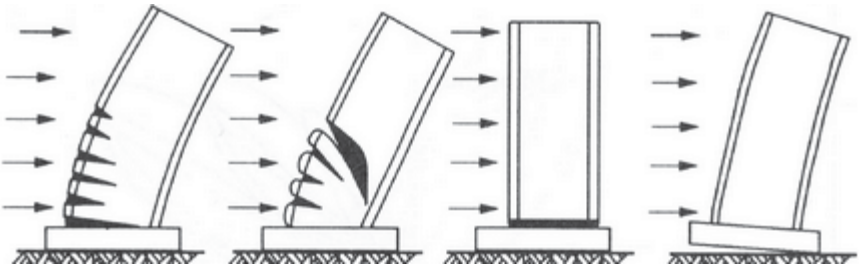
Figure 2 Failure modes of slender masonry structures: flexion; shear; rocking by base uplifting and rocking by foundation uplifting [Bazan and Meli, 2003]

NTCDF [2004] and Bazan and Meli [2003], affirm that the seismic behavior of walls differs importantly depending of their slenderness. Compact walls ($H/L \leq 2$) are dominated mainly by shear effects. By the other hand, slender walls ($H/L \geq 2$) behave mainly as cantilever beams with generally low vertical loading, dominating mainly the effect of flexion. If $H/L > 4$, the structure could be considered as excessively slender, being this the case of most of the historical masonry towers (Figure 4). This could cause its failure by flexion, shear, overturning by instability and transmission of elevated vertical loads to the foundation and soil as depicted in Figure 2.

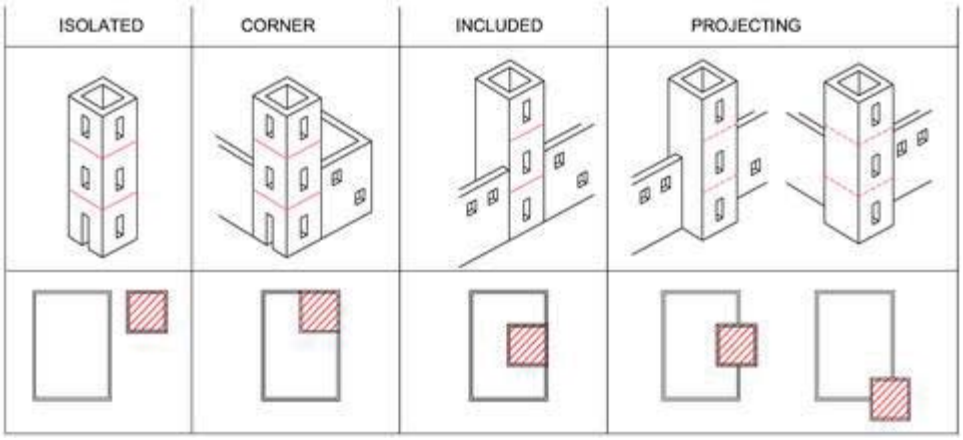
The position of a historical masonry tower in the urban context is a very important aspect that influences the vulnerability of the structure [Sepe et al., 2008]. These boundary conditions (see Figure 3) could strongly modify its seismic behavior and to have big impact in the generation of different failure modes. Non-isolated towers were commonly built as a part of a church or next to another building. The presence of adjacent walls or

Figure 3 Position of the tower in the urban context [Sepe et al., 2008]

Curti et al. [2008] observed in 31 Italian bell towers (16 isolated and 15 with one or two sides shared with the church) damaged by the 1976 Friuli earthquakes (May M6.4 and September M6.1), that the presence of walls and façades adjacent to any tower at different heights are horizontal constraints that increase the seismic vulnerability of the tower by limiting its slenderness and by creating localised stiffening zones that could cause the concentration of important stresses.

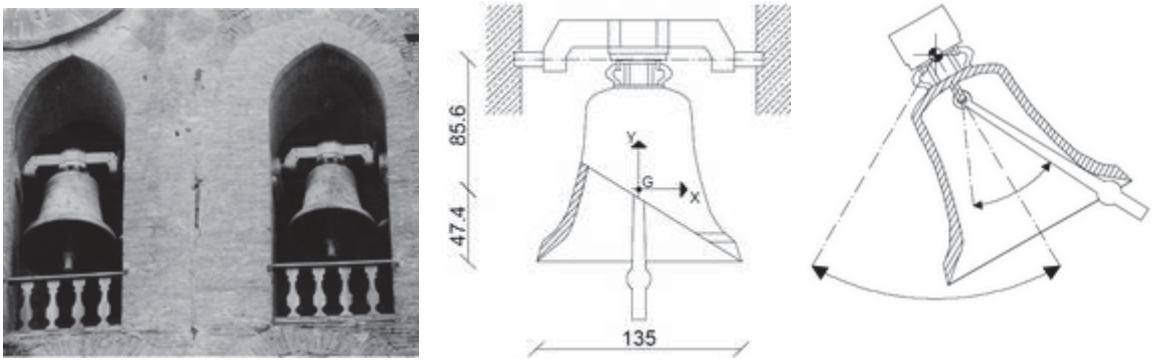
Figure 7 The bell tower of "Matilde" in Pisa, Italy: location of bells at belfry and crack pattern; bell dimensions (in cm) and bell swinging [Beconcini et al., 2001]

The swinging of the heavy bells induces dynamic actions that could cause damage to the tower. By the one hand, this motion generates at the bell´s support elevated vertical and horizontal inertia forces that are transmitted to the structure. Considering that most of the towers were built mainly to withstand their vertical loading, results more critical the action of the induced horizontal forces that could generate cracking or the separation of structural elements due to the low tensile strength of masonry (Figure 7). By the other hand, the excitation induced by the swinging of bells could be very close to one of the natural frequencies of the tower, leading to a high dynamic amplification of the structural response by the resonance effect. For more detailed information about the dynamic actions by bells swinging the reader is referred to Beconcini et al. [2001], Bennati et al. [2002] and Ivorra and Pallares [2006].
