# Fundamental Aspects on the Seismic Vulnerability of Ancient Masonry Towers and Retrofitting Techniques

## Abstract

**Keywords:** *towers; old masonry; earthquakes; vulnerability; behavior; failure modes; retrofitting*

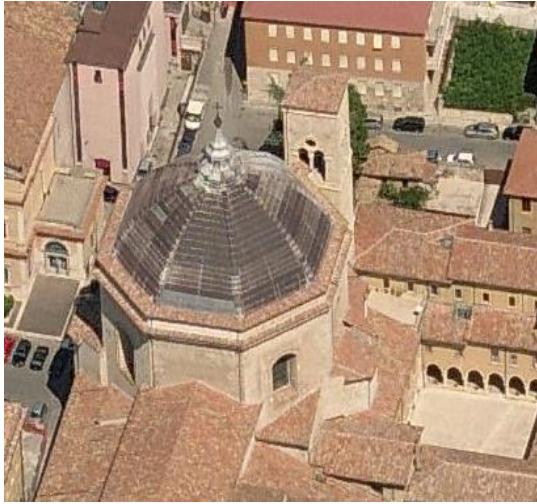
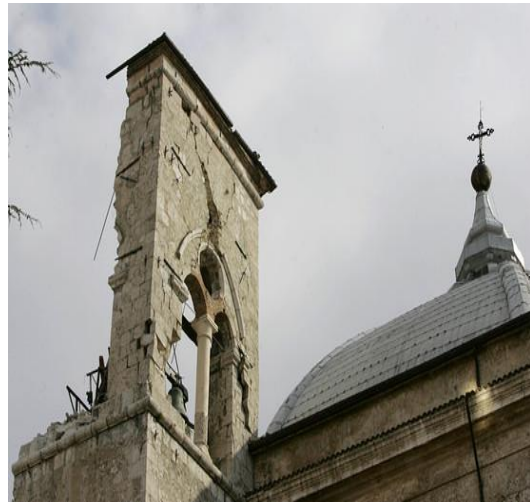
Fig. 3 San Bernardino church in original conditions and observed damage after the 6.3 magnitude earthquake of L'Aquila, Italy on April 6<sup>th</sup> 2009

The occurrence of unexpected and unavoidable events such as EQs has demonstrated that AMT are one of the most vulnerable structural types to suffer strong damage or collapse as depicted in Fig. 3. Their protection is a topic of great concern among the scientific community. This concern mainly arises from the observed damages after every considerable EQ and the need and interest to preserve these structures. Although the recent progress in technology, seismology and EQ engineering, the preservation of these brittle and massive monuments stills represents a major challenge. These vertical structures are slender by nature, where bending plays an important role in the seismic performance. Moreover, the seismic vulnerability of masonry towers is increased by certain important aspects such as soil characteristics, adjacent buildings, large openings at belfries, nonlinear behavior of masonry due to its poor tensile strength, lack of good connection between structural elements, high vertical loading and progressive degradation.

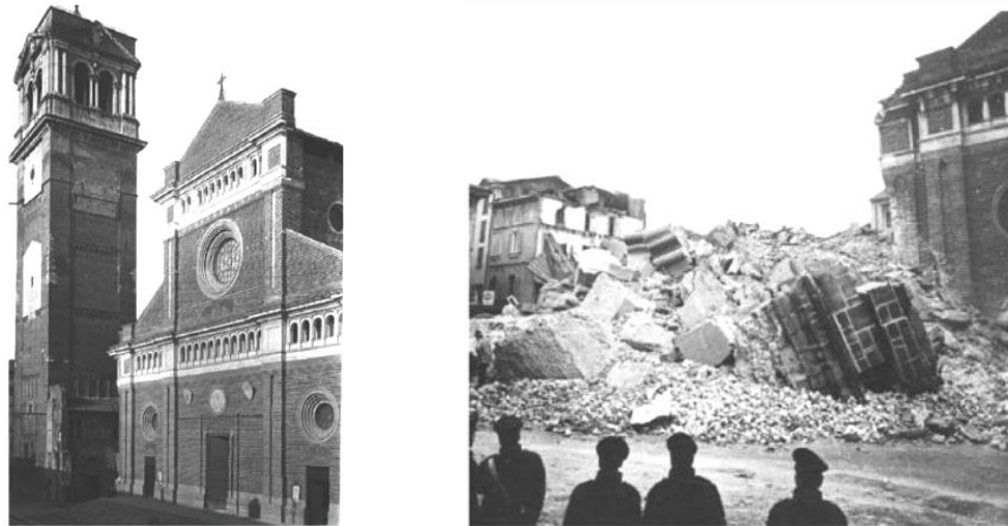
Fig. 7 The collapse of the historical civic tower of Pavia in 1989 (Binda, 2008)

AMT were built as most of the cultural patrimony to mainly withstand the vertical loading generated by their self weight. The wall thickness of towers used to be determined by means of empirical rules transmitted from generation to generation by trial and error mainly based on the height (in some cases taller than 60 m) and observed damages after EQs. This led to the construction of walls with enormous thicknesses higher than 2 m. The roof system of masonry towers was usually made of the same material of walls. Even when reduced thicknesses were considered, the elevated mass of masonry generated problems of instability that could lead to its collapse during the construction works. Due to this, is quite frequent to especially find in Italy masonry towers with a plane or leaned roof system integrated by timber beams and fired-clay bricks. In Germany the masonry towers usually have a triangular timber roof externally covered by thin copper plates. On the other hand, fired-clay bricks were frequently used in Mexico and in some cases volcanic stones of low density or artisanal clay vessels to make lighter the roof system. Towers are slender structures under high vertical loading due to the height, wall thickness, presence of a roof system, high density of masonry and heavy bells, leading to the concentration of high compressive stresses at the base. All these issues and the deterioration of masonry through the centuries (progressive damage) make AMT extremely vulnerable to suffer a sudden collapse by an exceeding of their compressive strength or foundation failure. These sudden collapses have been occurring since centuries ago in this type of structures. The most famous cases are reported e. g. in Binda *et al.* (1992), Macchi (1993), GES (1993) and Binda (2008). They correspond to the sudden collapses of the bell tower of “Piazza San Marco”, Venice in 1902 (a replica was built as depicted

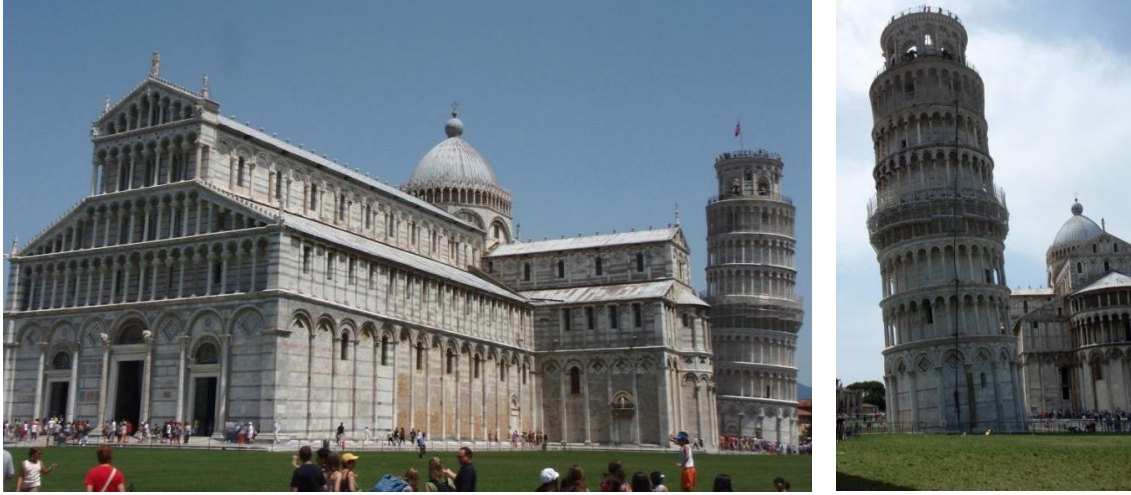
Fig. 8 General view of the leaning tower of Pisa, Italy

Mexico City since decades due to soft soil conditions. The most famous case presented in AMT is the leaning tower of Pisa, Italy. Since its construction in the XII century, it started to lean due to irregularities in the soil conditions, being as a result quite vulnerable to overturning (see Fig. 8).

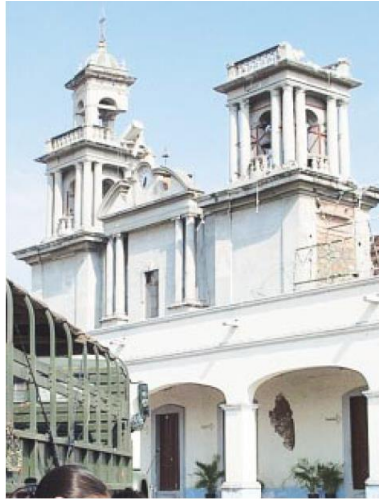
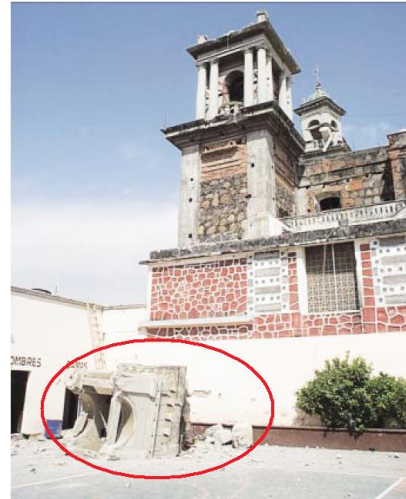
Fig. 9 Typical failure modes of bell towers; (a) Failure of belfries (Meli, 1998); (b) Effects of the Colima EQ M7.5 (2003) at bell towers

Fig. 9 Typical failure modes of bell towers; (a) Failure at belfries (Meli, 1998) and (b) Effects of the Colima EQ M7.5 (2003) at bell towers

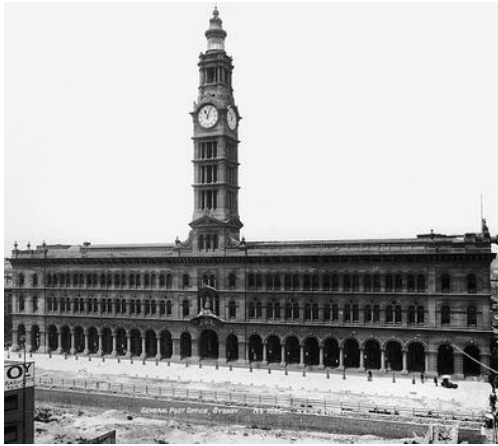
Fig. 12 The General Post Office clock tower in Sydney, Australia; (a) General view and (b) Details of the retrofitting measure (Ganz, 1990)

Fig. 12 The General Post Office clock tower in Sydney, Australia (Ganz, 1990)

Figure 12: The General Post Office clock tower in Sydney, Australia; (a) General view and (b) Details of the retrofitting measure (Ganz, 1990)

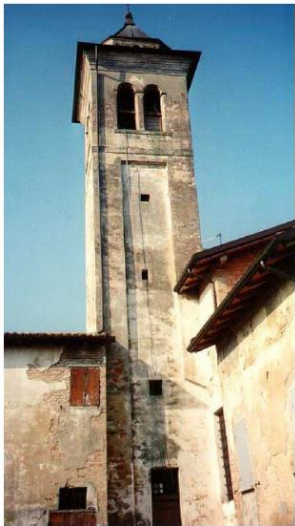
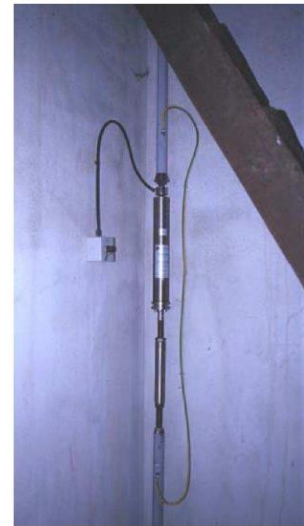
Fig. 13 The bell tower of the church of San Giorgio in Trignano; (a) General view; (b) Location of the retrofitting and (c) Installation of the devices (Indirli *et al.*, 2001)

Another famous real application of prestressing of towers was applied at the bell tower of the church of San Giorgio in Trignano, Italy (see Fig. 13). The bell-tower was strongly damaged by the 1996 M4.8 EQ. A combination of devices such as steel tendons and shape memory alloys (SMA) were vertically installed and without drilling at the four internal corners of the tower aimed to increase its bending and shear resistance. The combined devices were anchored at the top and foundation of the tower and post-tensioned with a prestressing force of 20 kN (80 kN total force). The retrofitting was verified by the occurrence of a similar EQ in 2000 with no damage of any type as explained in the works of Indirli *et al.* (2001) and Castellano (2001). However, in both real applications the retrofitting was validated in qualitative terms with no numerical simulations. Moreover, the way of determining the post-tensioning force is not mentioned and the use of a combination of a high resistance material such as steel with an extremely poor material such as masonry is doubtful in terms of compatibility of deformations and stresses concentration.

Fig. 13 The bell tower of the church of San Giorgio in Trignano; (a) General view; (b) Location of the retrofitting and (c) Installation of the devices (Indirli *et al.*, 2001)

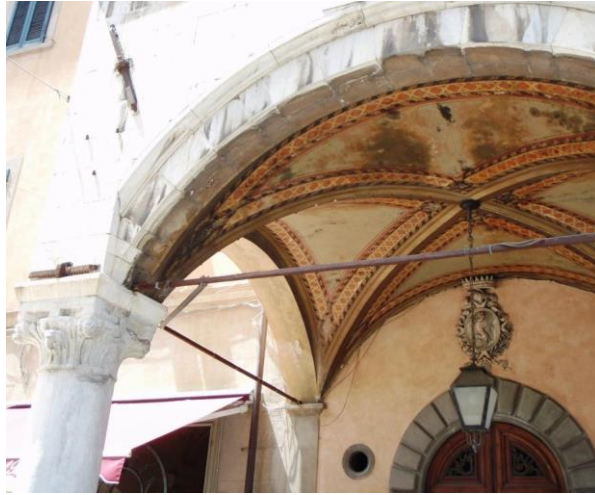
Fig. 14 Presence of horizontal prestressing steel bars in masonry vaulted structures

Horizontal external prestressing (see Fig. 14) has been mainly used in the cultural heritage to provide stability out-of-plane at walls or to reduce the tensile stresses generated by supports opening of vaults, arches and domes (Preciado, 2011). By the other hand, vertical external prestressing has proved to be more suitable to increase the in-plane lateral strength and ductility of masonry walls by providing tensile strength at key locations. The level of improvement strongly depends on the level of the prestressing force, so, the higher the prestressing force the higher the

Fig. 14 Presence of horizontal prestressing steel bars in masonry vaulted structures
