## **“Earthquake Protection of Colonial Bell-Towers in Colima, Mexico with Externally Prestressed FRPs”**

**Preciado, A., Budelmann, H. and Bartoli, G. (2016). “Earthquake protection of colonial bell towers in Colima, Mexico with externally prestressed FRPs.” *International Journal of Architectural Heritage, 10(4): 499-515, ISSN: 1558-3058***

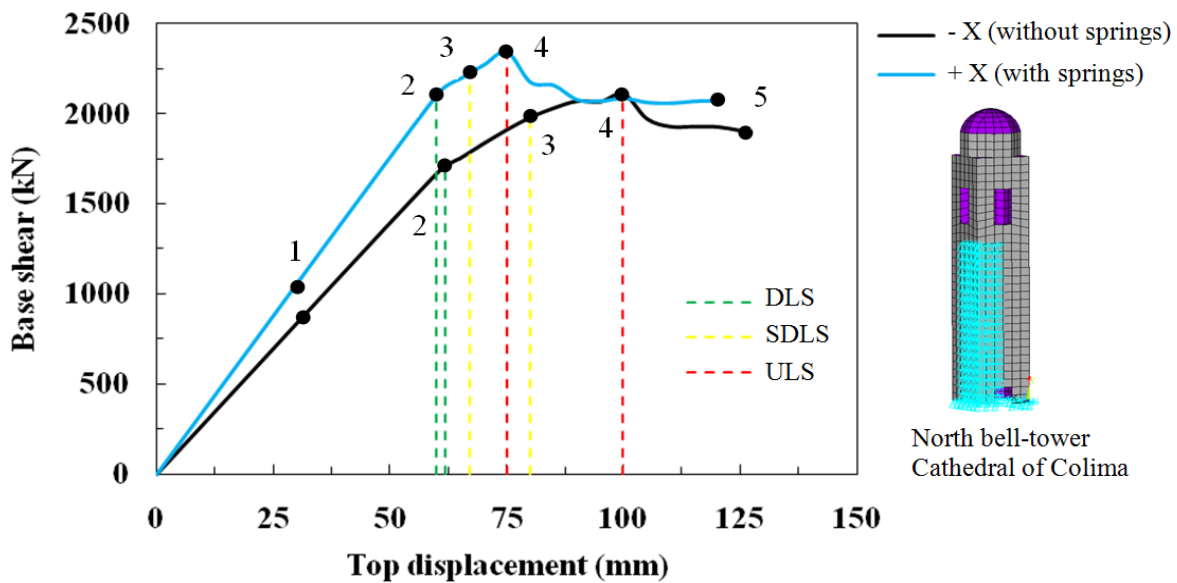
Figure 7: Comparison of capacity curves in original state for a seismic action in  $-X$  and  $+X$  with the damage grades (EMS-98) and limit states (EC-8)

capacity curves illustrated in Figure 7. It is worth noting that the left tower under seismic action in  $-X$  direction presents at ULS a maximum displacement of 100 mm and a lateral force of 2741 kN. Compared to the brittle constrained  $+X$  model, the  $-X$  model presents its characteristic bending behavior due to the disconnection with the façade, represented by 25% of more displacement capability (see Table 5). The  $+X$  model is more resistant to horizontal loading (12%), but less ductile, which is not relevant for seismic energy dissipation purposes, it is more important to reach more ductility with no brittle failure. For this purpose, the technique of prestressing is quite helpful to reach a seismic upgrading of URM structures by increasing strength, ductility and internal confinement.

In order to have comparative indicators of performance it is included at the capacity curves the EQ performance limit states established by the European Code (EC-8) (Eurocode 8, 2004); the damage limit state (DLS) at first yielding; significant damage limit state (SDLS) representing significant damage and the ultimate limit state (ULS) near collapse. Moreover, these limit states

at the capacity curves are correlated to the damage grades (DG) DG2, DG3 and DG4 proposed by the European Macroseismic Scale (EMS-98) reported in Grünthal (1998). For having quantitative indicators of performance at the capacity curves, it is included the seismic coefficient (CS) determined by the ratio between the ultimate lateral force and the vertical loading. The seismic coefficient is typically expressed as a fraction or percentage of the gravity (g). The main drawback of this indicator is that only the lateral strength of the structure is evaluated, disregarding the displacement and ductility which is extremely important in the EQ assessment of structures for energy dissipation capabilities (see Tables 5 and 6).

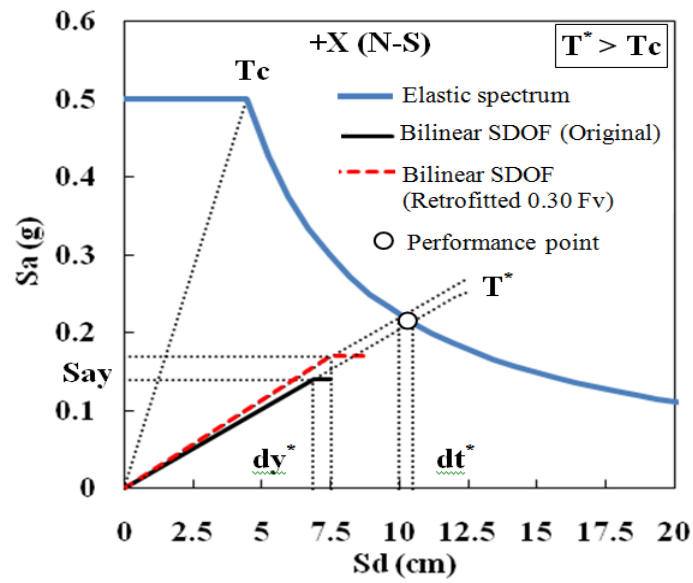
Figure 9: Seismic evaluation of the north bell tower of the Cathedral of Colima by the Capacity Spectrum method: (a)  $-X$  direction and (b)  $+X$  direction (springs)

Figure 9 illustrates the converted capacity curves of the -X (disconnected) and +X (constrained) models, as well as the elastic response spectrum based on the seismic hazard characterization of Section 3. Since  $T^* > T_c$ , the target displacement is directly obtained without reducing the elastic response spectrum. Figure 9 illustrates the transformed capacity curves into bilinear curves of the -X and +X model for computing the ductility available against the seismic demand. The maximum reached displacement  $dm^*$  for both models (-X and +X) is not enough to withstand the seismic demand represented by the target displacement  $dt^*$  (performance point). The maximum performance of the -X model is of about 19% less than the required performance and even more drastic the +X model with a poor performance in the order of 40% (Table 7). The -X model fails more ductile than the +X model as depicted on Figures 5a and 6a. The +X model presents flexural cracks at the lower part of the body and failure of belfry by a combination of bending and shear stresses that allowed it to perform better than the +X model, which fails by shear stresses at belfry.
